# Advanced Gas Turbine **AGT**

DOE/NASA/0168-5  
NASA CR-168056  
DDA EDR 11185

## Power-Train System Development

### Fifth Semiannual Report

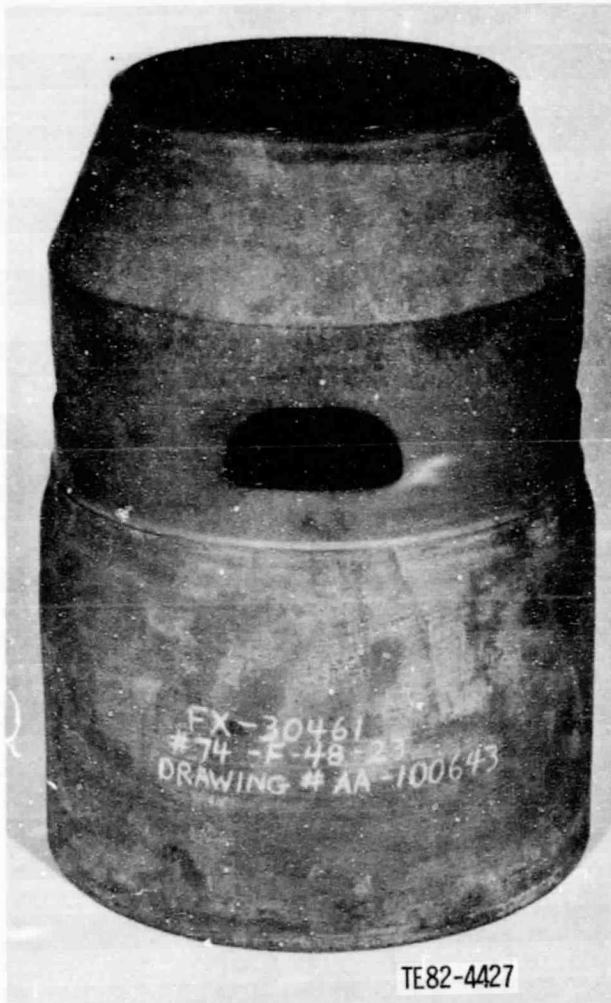
**Figure 58. Machined CBO combustor body.**

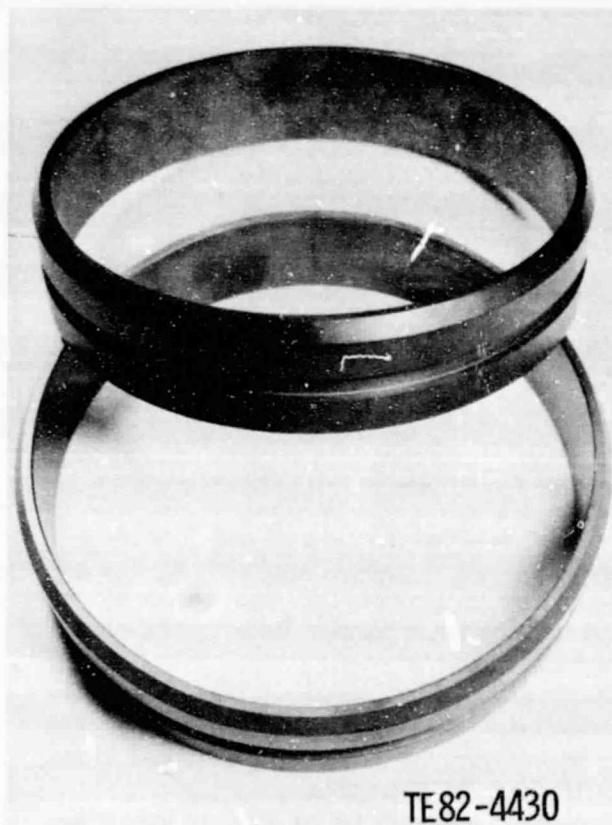
**Figure 61. CBO dilution bands.**
